**UNITED STATES DISTRICT COURT
SOUTHERN DISTRICT OF OHIO
WESTERN DIVISION**

KIA MOTORS AMERICA, INC., and
KIA MOTORS CORPORATION,

Case No. 1:15-cv-506

**DECLARATION OF THOMAS READ IN
SUPPORT OF PLAINTIFF'S MOTION
FOR CLASS CERTIFICATION**

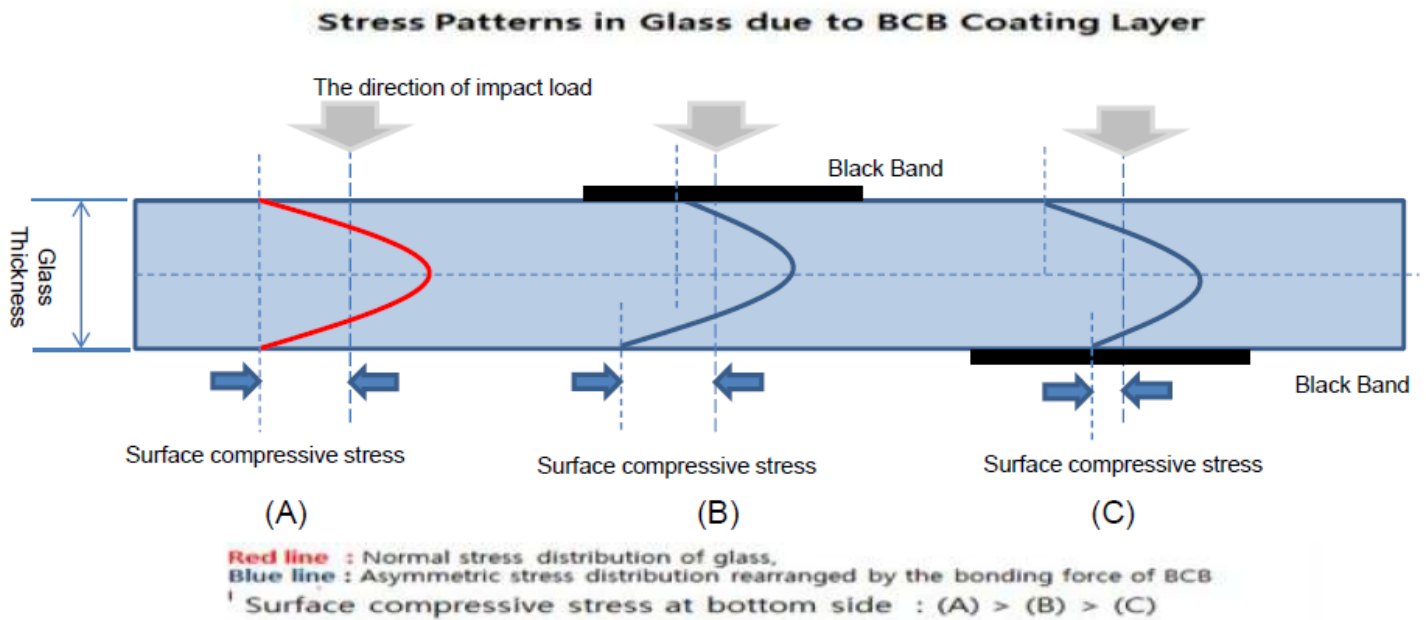
non-heat strengthened glass and is vulnerable to impacts or vibration leading to the total failure of the glass.²¹ Images of the ceramic print's effect on glass is below.

Figure #4: Kia schematic diagram showing the effect of printed and fired frit on the stress profile of a fully tempered piece of glass.²²

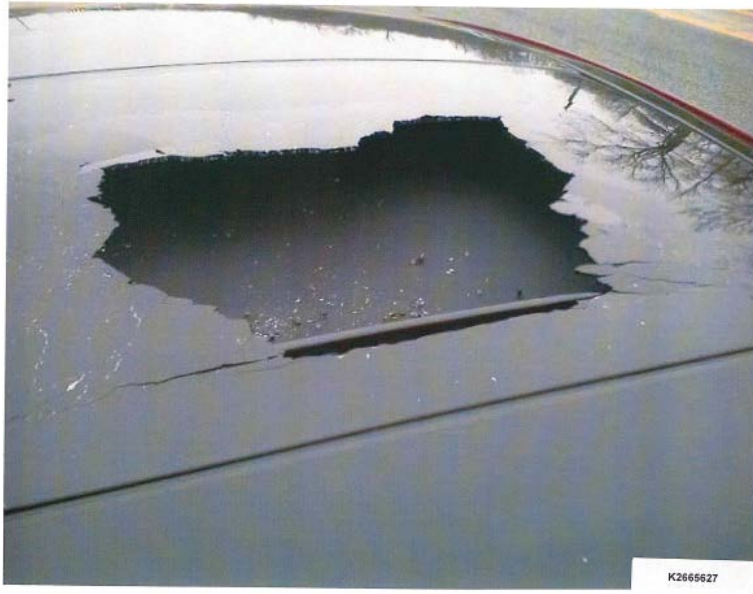
Figure #6: Above is a photograph of a 2014 Kia Optima with a broken sunroof produced by Kia to NHTSA.³⁴

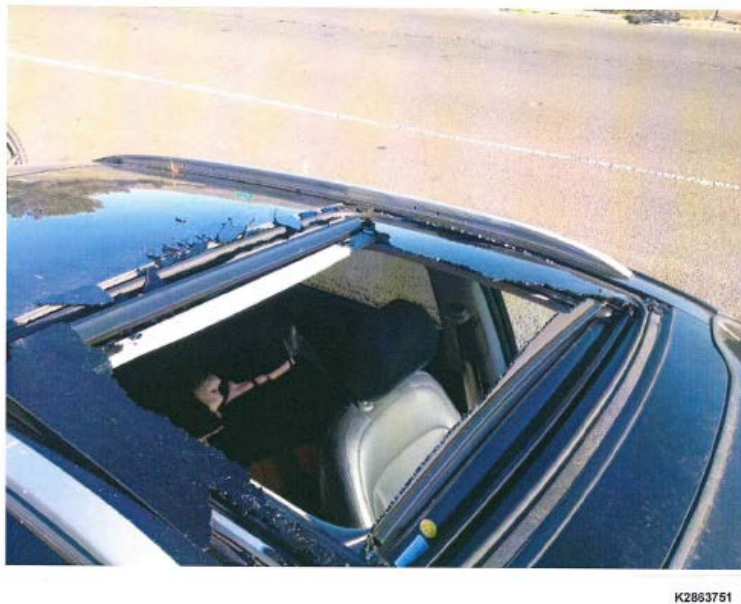
Figure #7: Above is a photograph of a 2012 Kia Sportage with a broken sunroof produced by Kia to NHTSA.³⁵

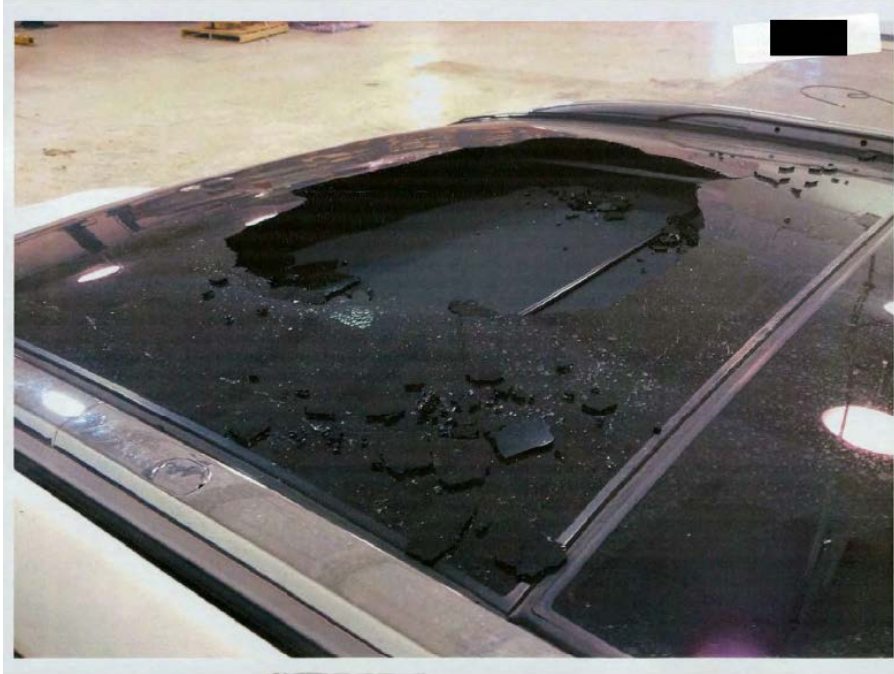
Figure #8: Above is a photograph of a 2014 Kia Sorento with a broken sunroof produced by Kia to NHTSA.³⁶

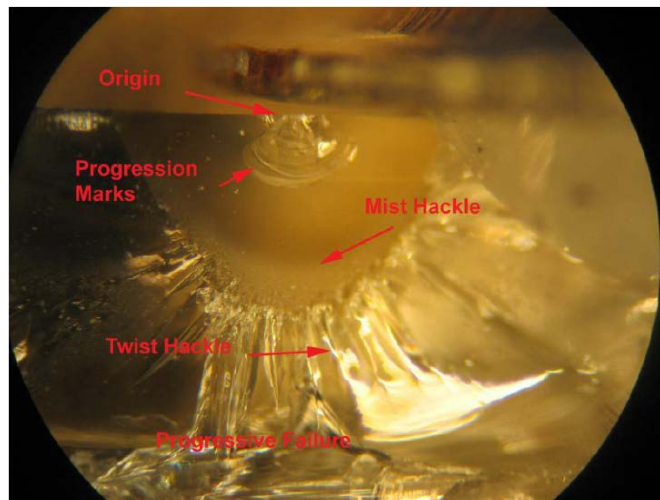
Figure #13: Photomicrograph of a known progressive tempered glass failure. This failure was initiated where a steel cup washer was rubbing on the underside of the tempered glass pot lid. Over time the rubbing combined with thermal cycling created a progressive flaw in the glass that penetrated the outer compression layer into the tensile region and the glass cover self-destructed. This is not an impact failure.

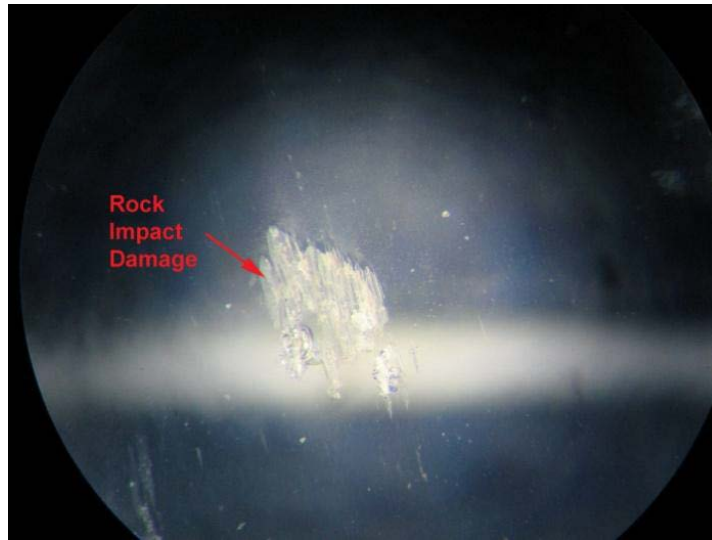
Figure #14: A fully tempered glass panel was impacted with a rock, but the impact did not cause failure. The surface damage is abrasive in nature.

49. The damage observed in these failures did not appear to be abrasive in nature, as depicted in Figure #14.

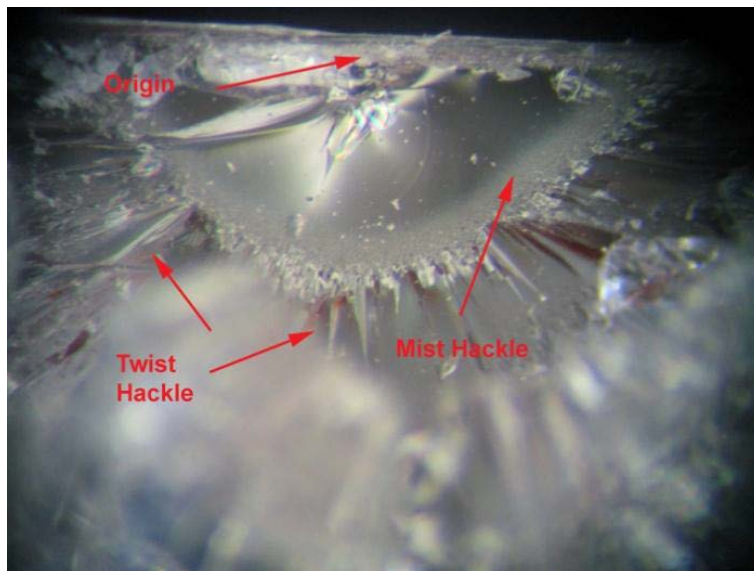
Figure #15: The damaged panel above, also shown in Figure #16, was then put under bending load to failure. The failure originated at the abrasion shown in Figure #16. The origin is shown above. This failure is not progressive in nature. However it demonstrates that post-damage stresses can drive a defect to failure. (Mag. 40X).

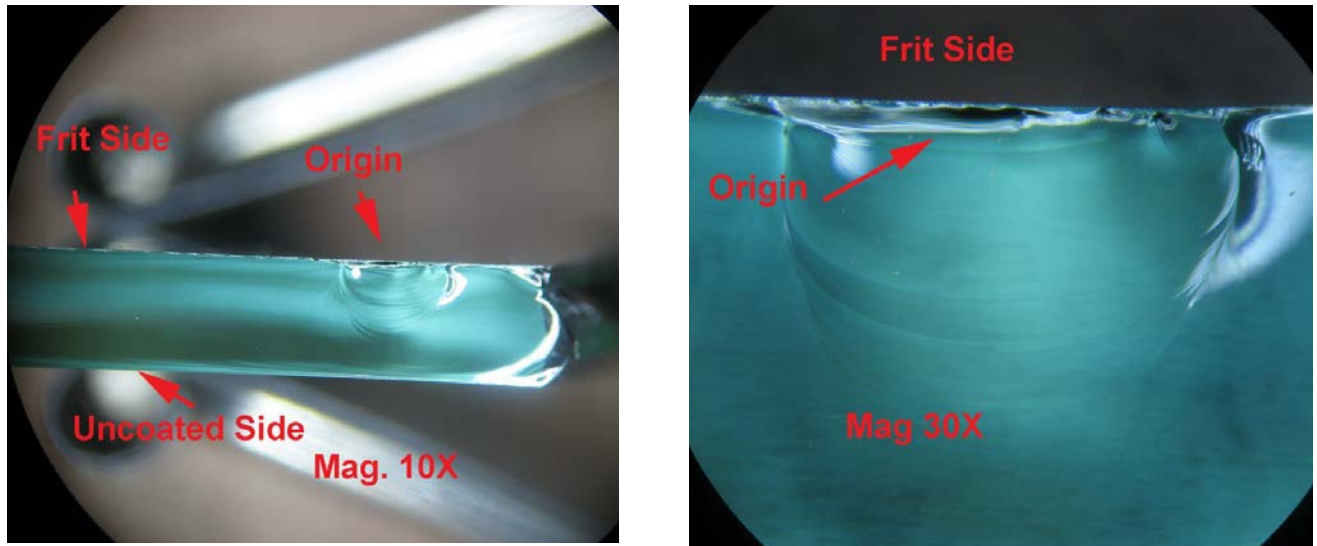
Figures #16 and #17: Photomicrographs above showing a thermal shock that initiated a failure under the frit in tempered glass. This demonstrates that the glass in contact with the frit is not fully tempered.

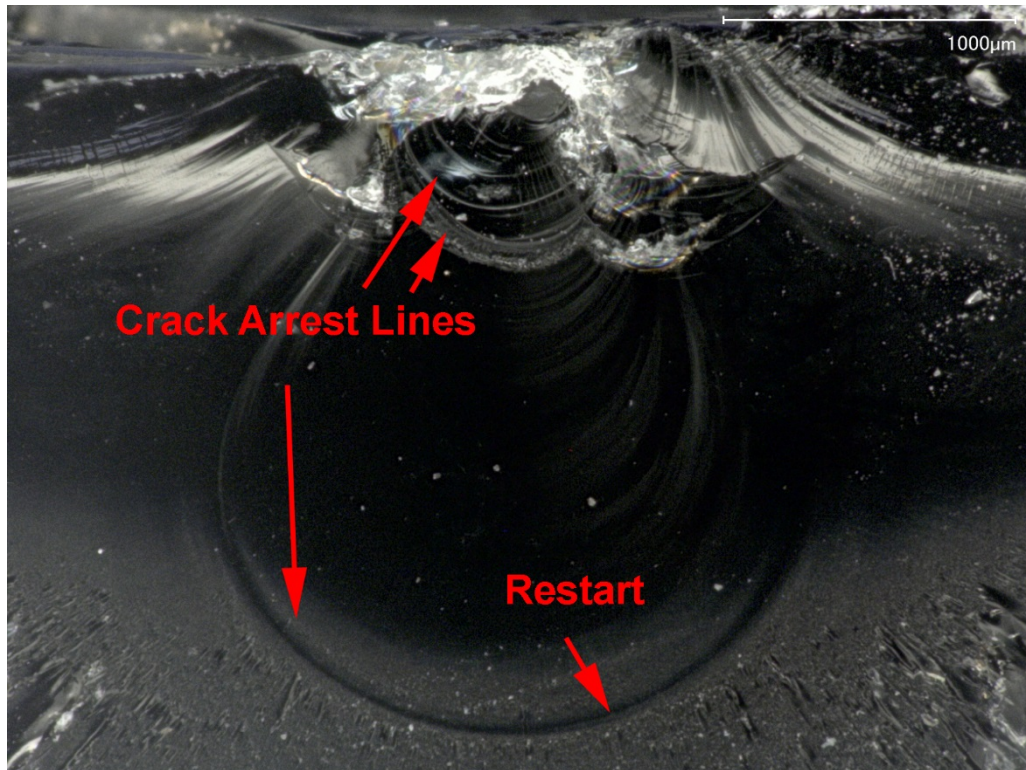
48. In my opinion, one of the failures appear to be a direct impact failure. It is my opinion that one of the remaining failures resulted from non-impact tensile stresses on the glass. Ten of the remainder are progressive failures as discussed above. Unlike direct impact failures, there was minimal crushed glass or post failure crushed glass. In addition, there were no apparent “Hertzian cones”.

Figure #18: Photo micrograph of the origin of Kia Sample #150901. This is a representative progressive failure that originated as a minor surface defect. Much of the visible damage at the origin (i.e. crushed glass) occurred after failure.

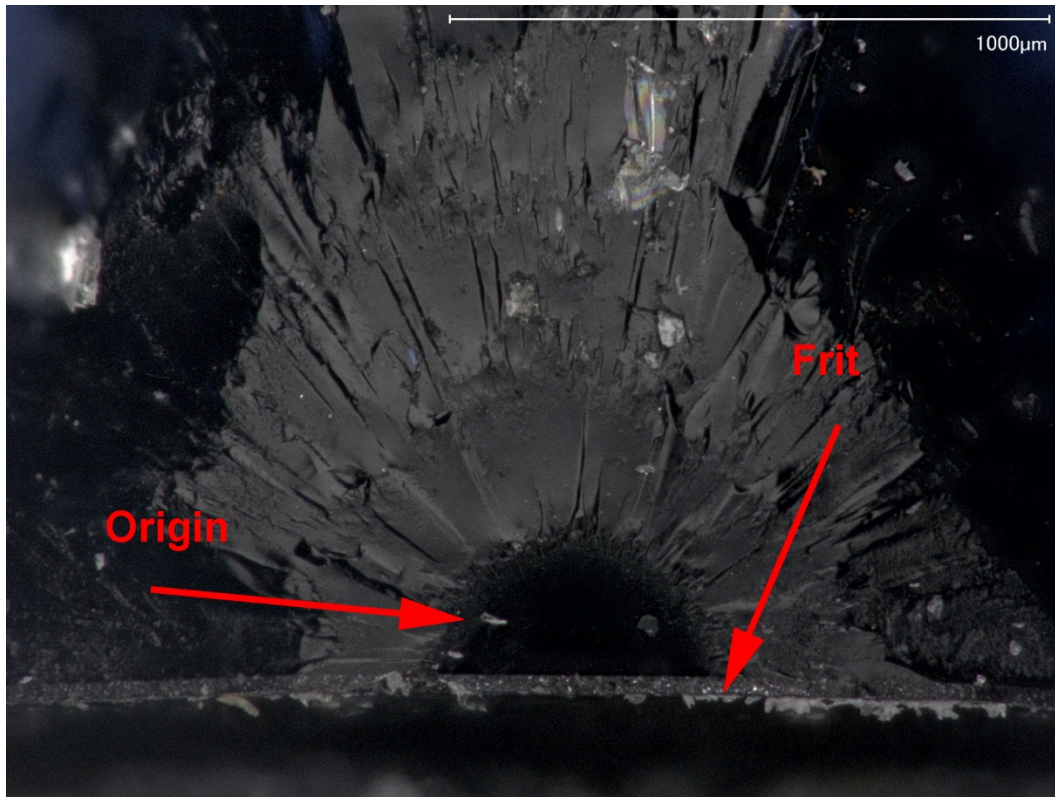
Figure #19: Photomicrograph of the origin of Exponent Kia Sample #160006. This is a failure originating on the frit side of the sunroof due to bending. This is not associated with impact.
